Contending with Corrosion in Metal Exteriors

High-performing, long-lasting, and resilient, PVF film is the technology of choice for corrosive environments

Sponsored by Dupont | *By Barbara Horwitz-Bennett*

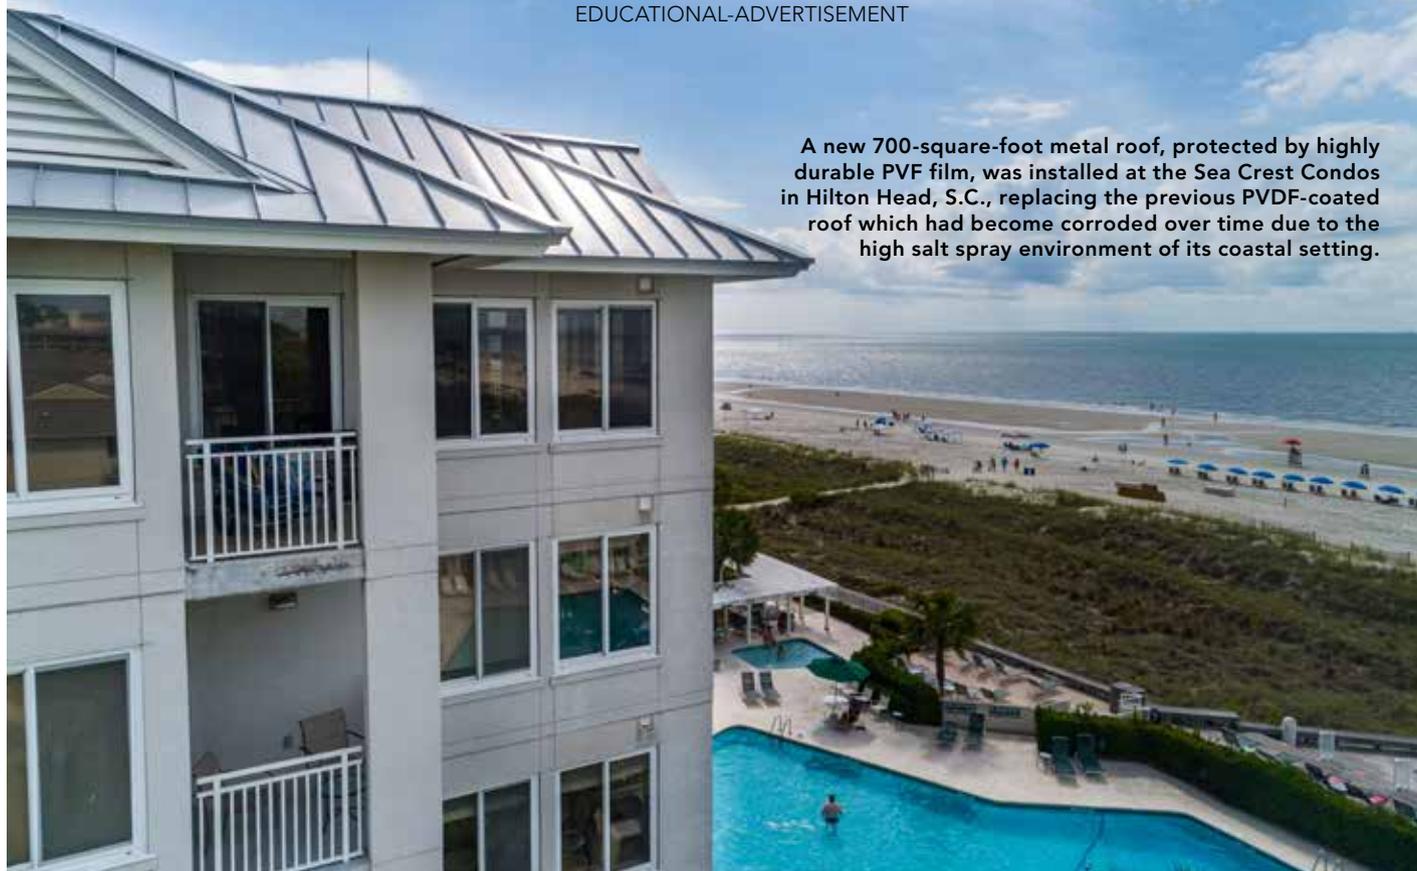
A new 700-square-foot metal roof, protected by highly durable PVF film, was installed at the Sea Crest Condos in Hilton Head, S.C., replacing the previous PVDF-coated roof which had become corroded over time due to the high salt spray environment of its coastal setting.

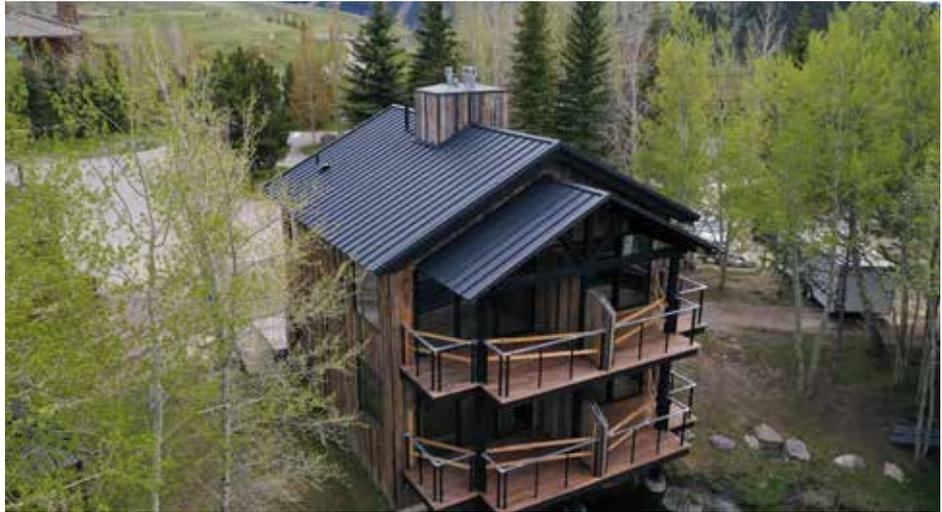
Delivering aesthetics and a high level of protection, a matte black PVF film covers 15 new metal roofs at the Spring Creek Ranch Hotel & Spa in Jackson Hole, Wyo.
